Kent Hidden Fixing Corner Guard

Kent Hidden Fixing Corner Guard (KHCG-80) has a 3 cornered profile which provides maximum protection, stability and rigidity whilst the raised edges ensure a smooth flush finish to tiled or other surfaces.

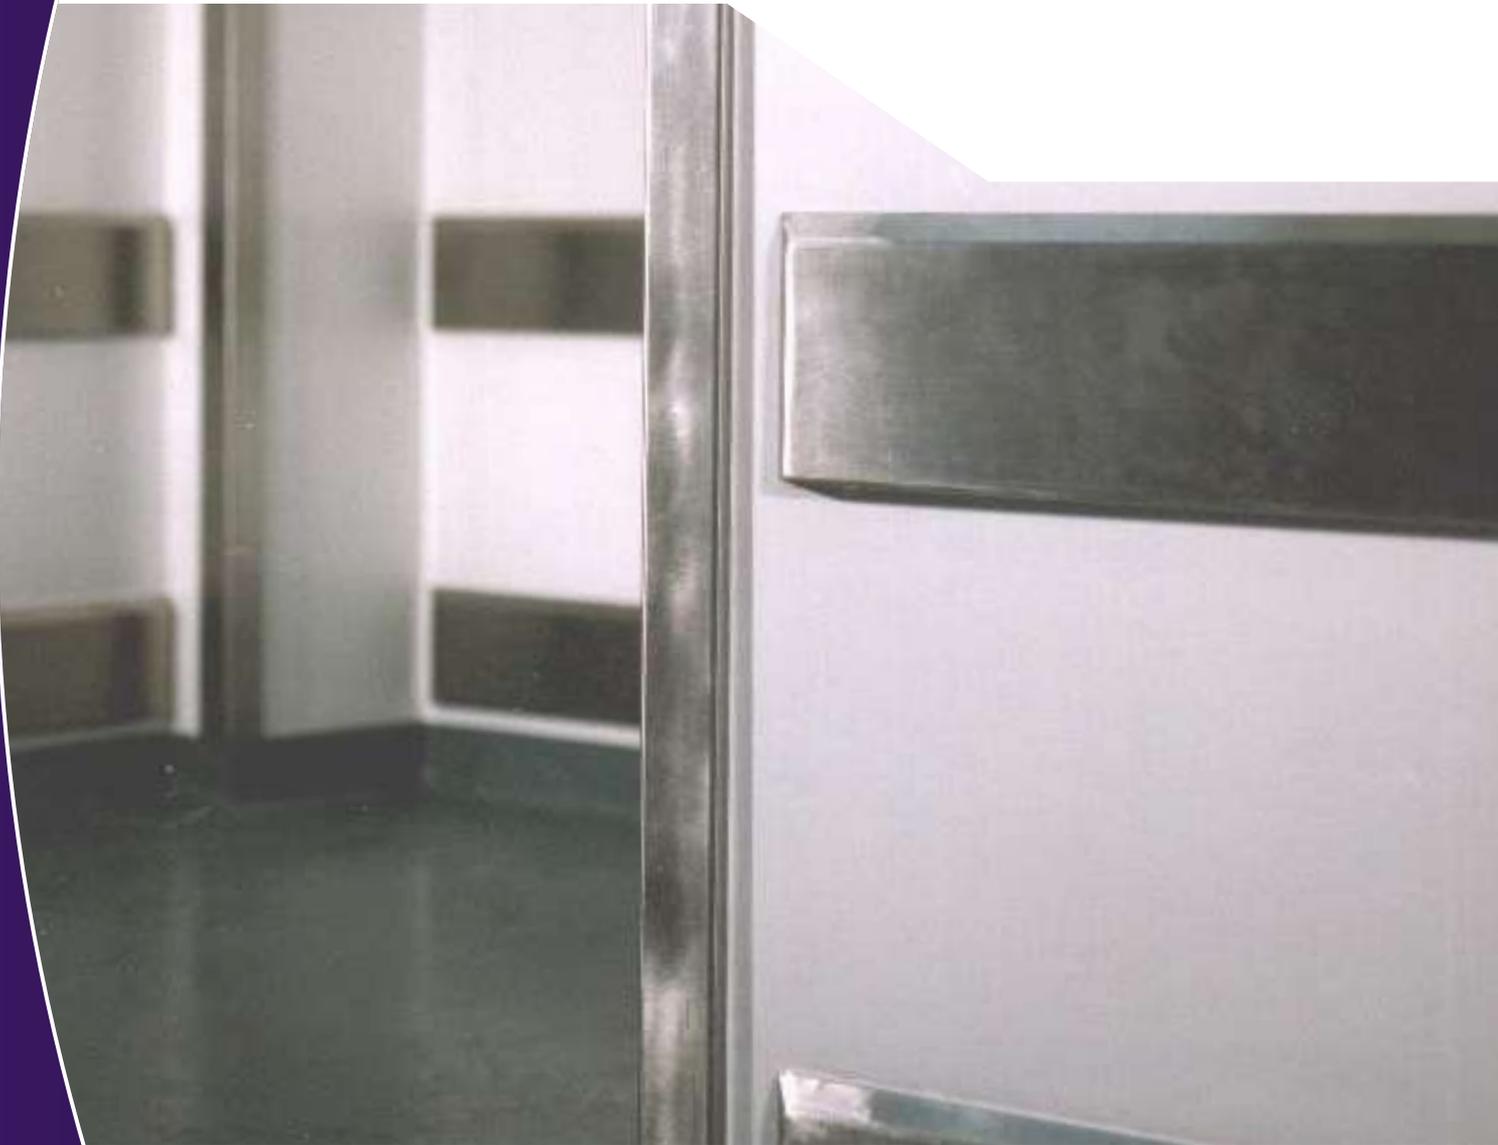
This can stand proud off the corner or tiled surfaces, or manufactured to be flush with the tiled surface.

The top edge is chamfered as standard. It can also be closed off horizontally for when adjacent to a ceiling.

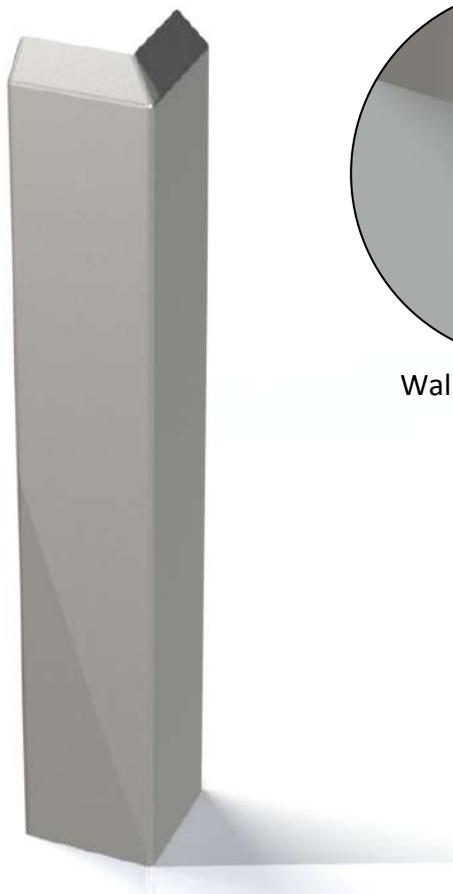
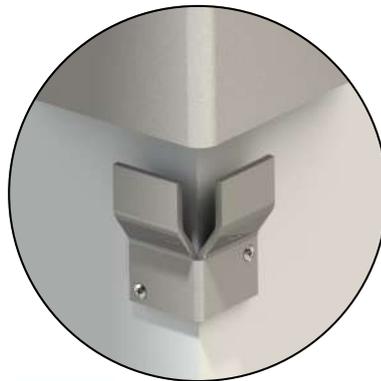
Wall Mounted Hidden Fixing Bracket

- 2mm or 3mm thick steel
- Satin finish 320 Grit polished
- Grade 304L stainless steel
- Easy to maintain & clean
- 2 brackets per 1000mm
